CULTURAL LANDSCAPE REPORT
FOR THE SANDY HOOK
COASTAL DEFENSE BATTERIES
GATEWAY NATIONAL RECREATION AREA

CULTURAL LANDSCAPE REPORT FOR THE SANDY HOOK COASTAL DEFENSE BATTERIES

GATEWAY NATIONAL RECREATION AREA

FORT HANCOCK, NEW JERSEY

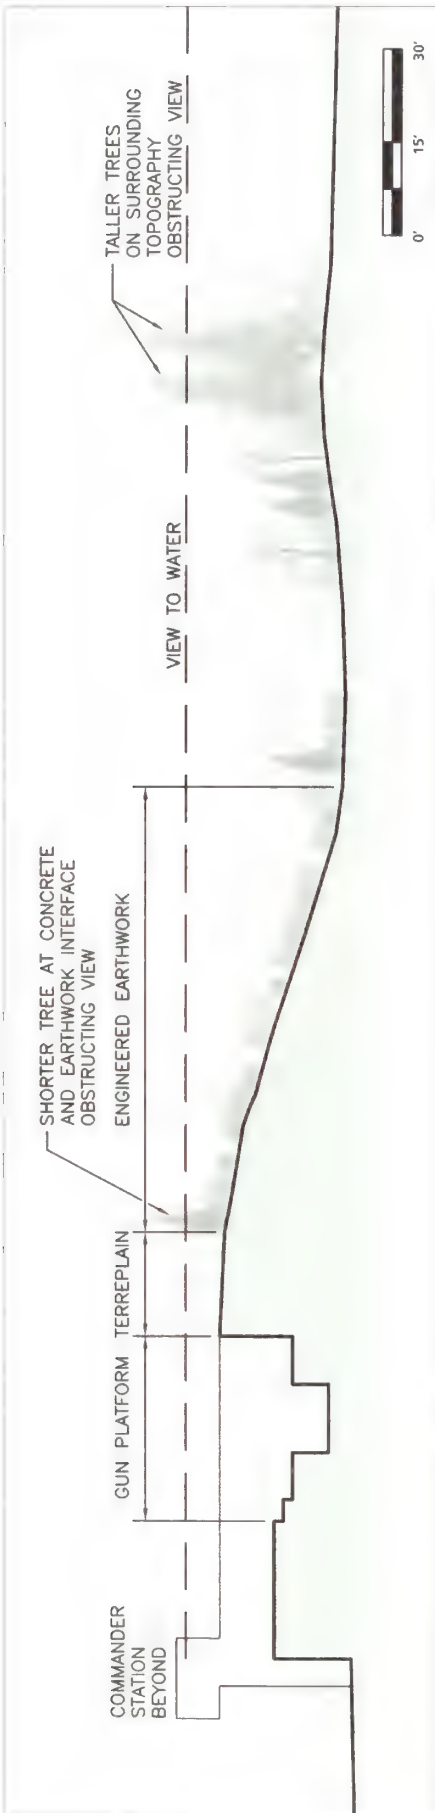
Existing Condition: Tactical views from the emplacements, battery commander's stations, and fire control stations to the water are primarily impeded by woody vegetation growing at the interface of the engineered earthwork and concrete battery structure (Figure 4.5 and see Figures 3.4 and 3.42). Beyond the toe or bottom of the engineered earthwork there may be vegetation that impacts views, however, the impact is difficult to evaluate with obstructing vegetation in close proximity to the start of the view. With the exception of the communications trailer and observation platform at Batteries Engle and Peck, there appears to be no additional buildings or structures that impact views from the emplacements, battery commander's stations, and fire control stations.

Figure 4.5. Conceptual section through a disappearing gun battery. The section is drawn through a gun emplacement for a concrete battery such as Battery Granger or Nine Gun Battery. Tactical views from the emplacements, battery commander's stations, and fire control stations to the water are primarily impeded by woody vegetation growing at the interface of the engineered earthwork and concrete battery structure (Olmsted Center, 2009).

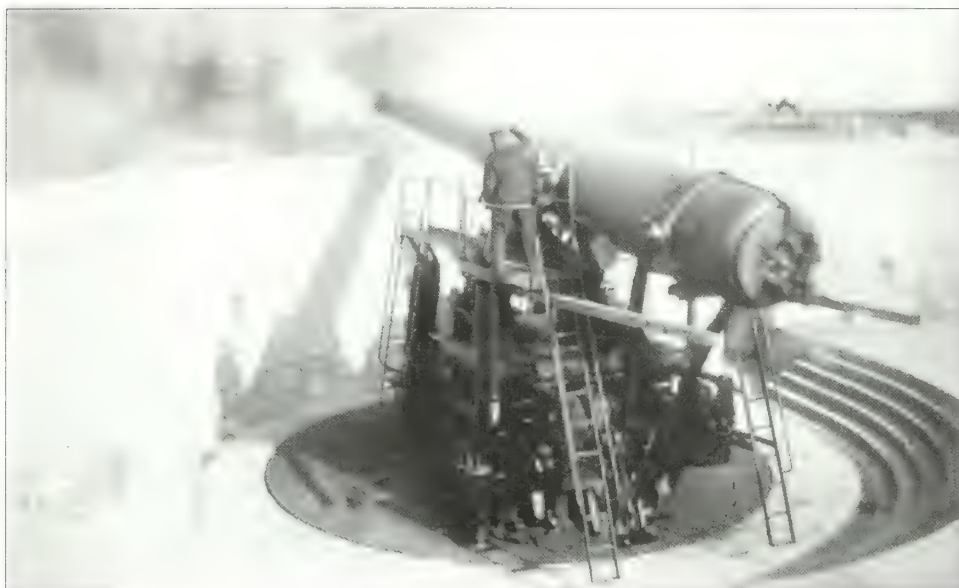
Feature	Extant 1945	Extant 1974	Extant 2009	Contrib- uting	Notes
Tactical Views					
Downrange views from the gun carriage and battery commander's stations	Yes	Un- deter- mined	No	Yes	A raised platform on the gun carriage allowed an artillery officer views over the concrete structure to a potential target. Figure 4.8. Although the gun carriages are not extant, views from a comparable vantage point and from the battery commander's stations are presently obstructed by large woody vegetation, especially tall vegetation growing on the concrete terreplein and at the interface of the engineered earthwork and concrete battery structure. See Figure 3.21.
Small-Scale Features					
Chain-link fence west of Nine Gun Battery	No	No	Yes	No	The National Park Service installed a chain-link fence and signage to warn visitors of potentially hazardous conditions and block access to Nine Gun Battery's west elevation.

Figure 4.8. View looking southeast at artillery firing, Battery Richardson, Nine Gun Battery, circa 1905–10. A raised platform on the gun carriage allowed an artillery officer views over the concrete structure to a potential target. Although the gun carriages are not extant, views from a comparable vantage point and from the battery commander's stations are presently obstructed by large woody vegetation (Thomas Hoffman, *Fort Hancock*, Charleston, SC: Arcadia Publishing, 2007).

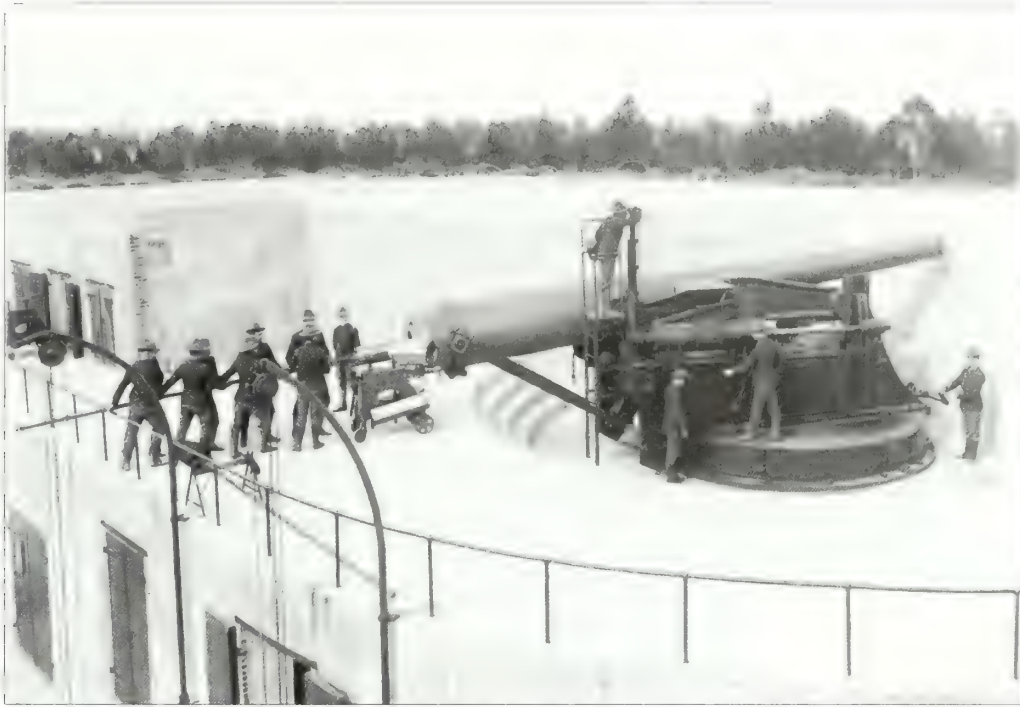
Tactical Views					
Downrange views from the gun carriage and battery commander's stations	Yes	Un-determined	No	Yes	A raised platform on the gun carriage allowed an artillery officer views over the concrete structure to a potential target. Figure 4.10. Although the gun carriages are not extant, views from a comparable vantage point and from the battery commander's stations are presently obstructed by large woody vegetation, especially tall vegetation growing at the interface of the engineered earthwork and concrete battery structure. See Figure 3.35.
Small-Scale Features					
Chain-link fence west of battery	No	No	Yes	No	The National Park Service installed a chain-link fence and signage to warn visitors of potentially hazardous conditions and block access to Battery Granger's west elevation.
Wayside west of battery	No	No	Yes	No	The National Park Service installed an interpretive wayside west of Battery Granger.

Figure 4.10. View looking northeast at emplacement #1, Battery Granger, 1899. A raised platform on the gun carriage allowed an artillery officer views over the concrete structure to a potential target. Although the gun carriages are not extant, views from a comparable vantage point and from the battery commander's stations are presently obstructed by large woody vegetation (GATE 7778).

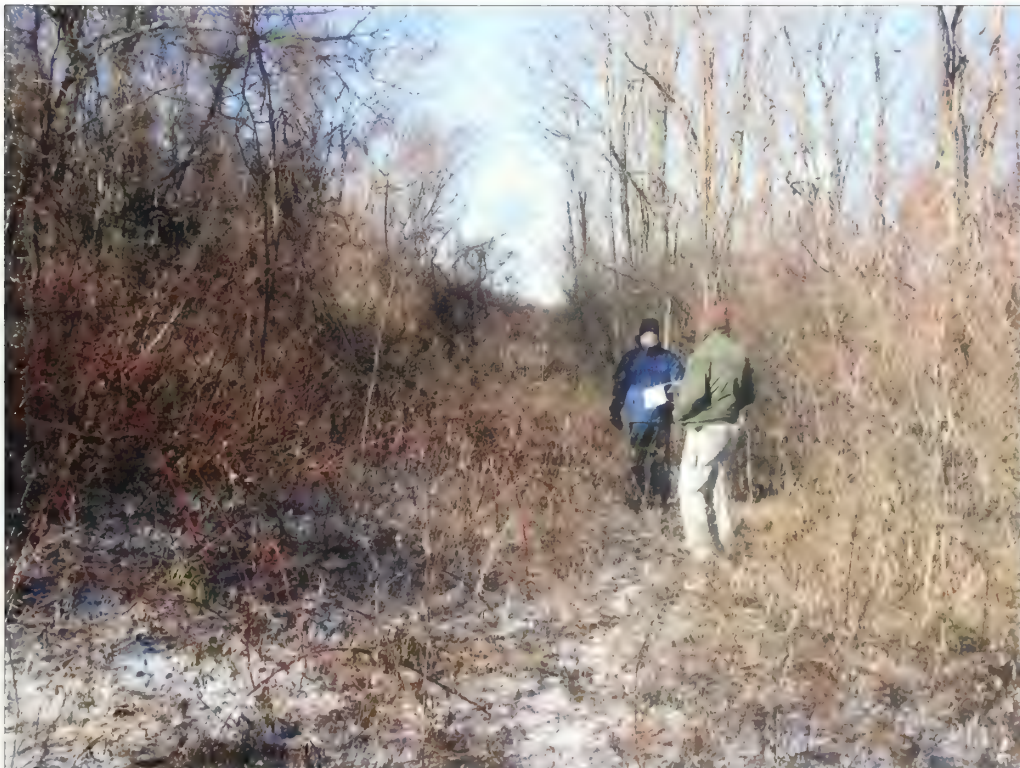
Trail north of battery	Yes	Yes	Yes	Yes	By 1942, an unpaved road was installed north of the battery. Presently, the road is almost entirely overtaken by vegetation and barely passable as a trail. Figure 4.11.
Buildings and Structures					
Four mortar pits organized into two firing batteries with underground connecting galleries, magazines, and storage rooms.	Yes	Yes	Yes	Yes	The battery contains four mortar pits that are recessed in a protective mound of earth and sand rising to almost thirty-five feet. The earthen mound is bound by a rectangular concrete wall. At the wall's southwest and northeast corners, counterscarp galleries were constructed to defend against a land-based attack. The Army designated the two north mortars Battery McCook and the south mortars Battery Reynolds.
Telephone data booths	Yes	Yes	Yes	Yes	One story, rectangular, concrete building located above the southwest corner of each mortar pit and supported by arched, concrete spans. The booths received instructions on aiming artillery and relayed the information to the mortar pits. See Figure 3.37.

Figure 4.11. View looking northwest at trail north of the Mortar Battery. By 1942, an unpaved road was installed north of the Mortar Battery that presently is overtaken by vegetation and is barely passable as a trail (Olmsted Center, January 2009).

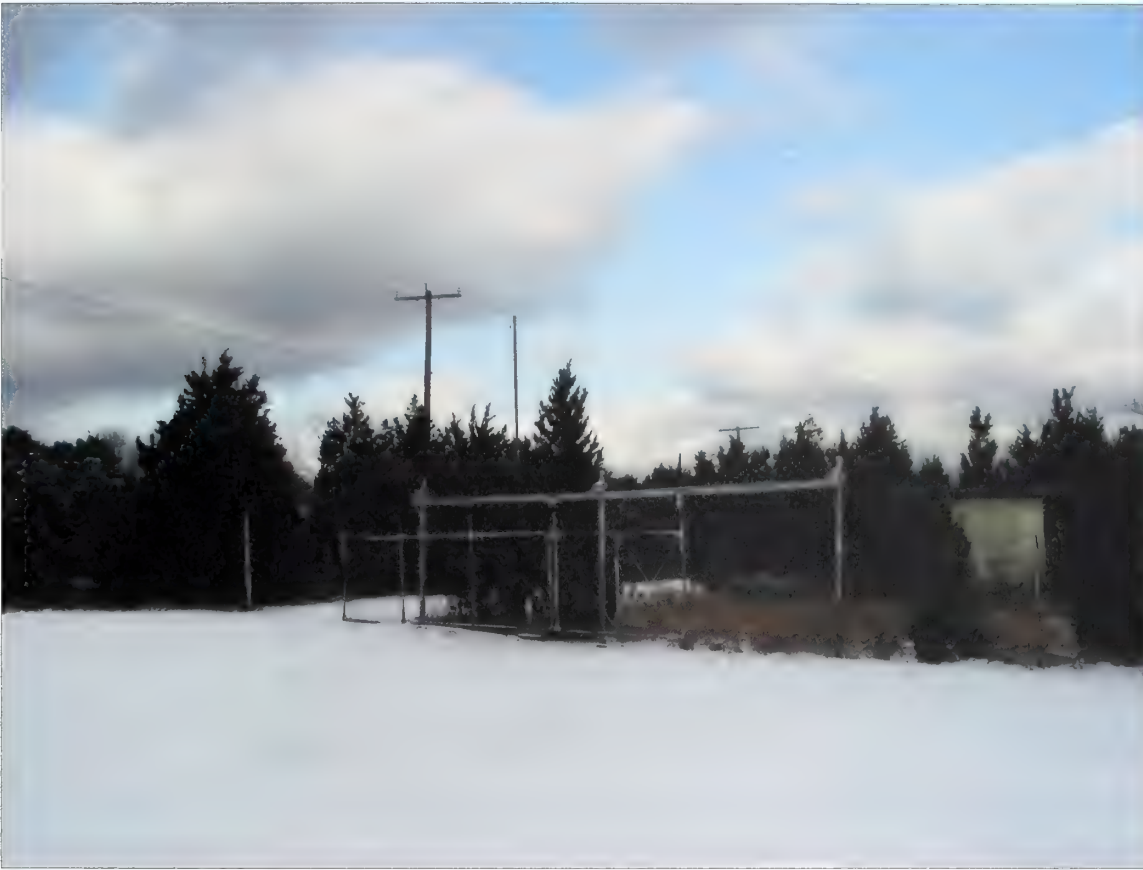
Figure 4.26. View looking northeast at access gate to Missile Magazines and Missile Maintenance Area, NIKE launch site. Following the site's closure woody species, especially eastern red cedars, have emerged and are growing in close proximity to the buildings. The Paint and Oil Storage shed (447) can be seen on the right foreground surrounded by eastern red cedars (Olmsted Center, January 2009).

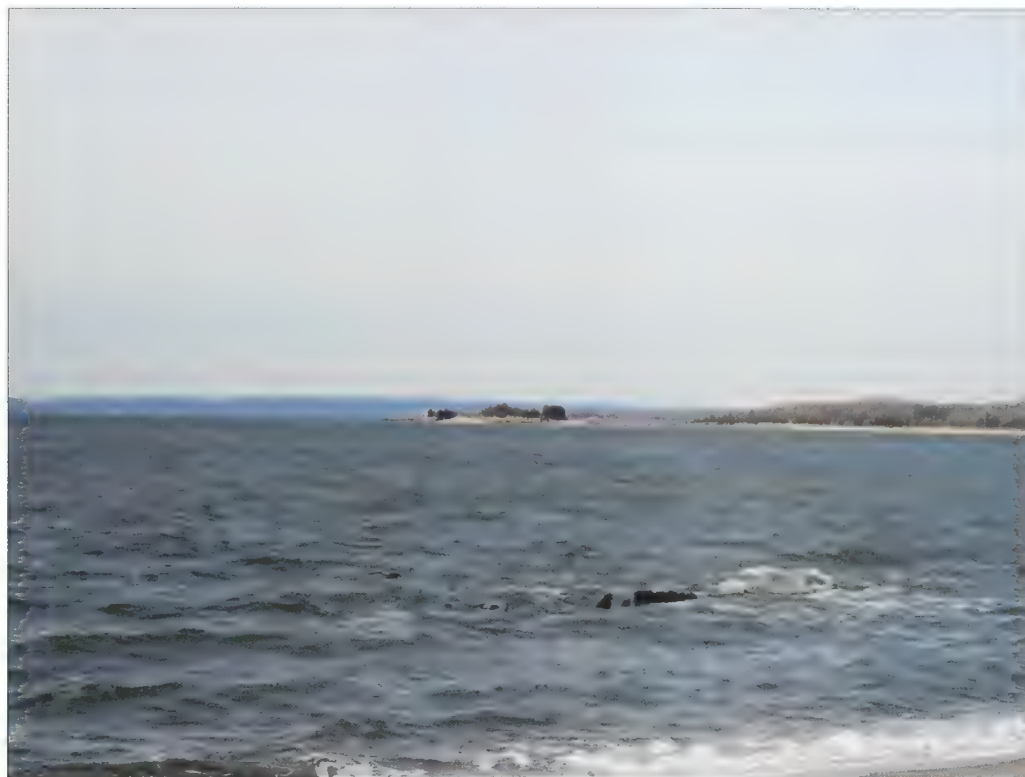
Figure 5.4. View looking northwest at Battery Arrowsmith. Coastal storms continue to break apart Battery Arrowsmith and the peninsula along Horseshoe Cove (Olmsted Center, January 2009).

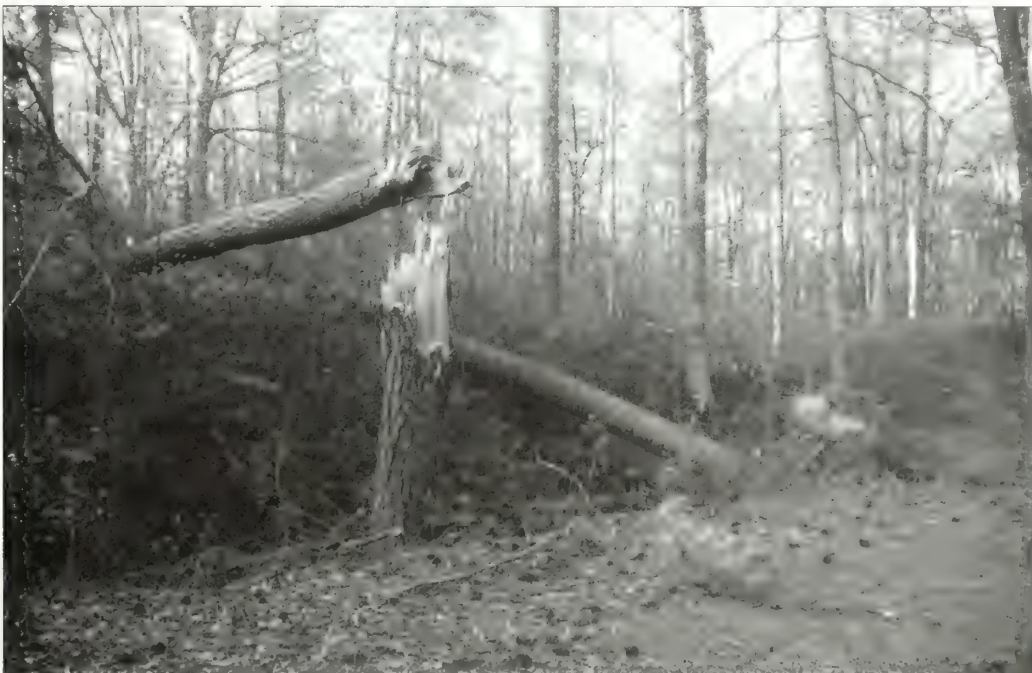
Engineered slopes historically supported vegetation as part of a concealment strategy. However, large trees were not permitted to grow to an extent where they compromised the integrity of the engineered landform, or obstructed the effective field-of-fire. Since their period of active service, unmanaged woody vegetation has obstructed views and threatens the long-term preservation of the earthworks and structures below them. The root systems of these woody species have penetrated the earthwork and have the potential to exploit and damage pores in the concrete structures. As the canopies of these woody species continue to grow, there is a risk that snow, ice, and wind could topple a tree and a major portion of the engineered earthwork would be removed with the tree’s roots (Figure 5.6).

Figure 5.6. Storm-thrown tree, Union Fort Fisher, Petersburg National Battlefield. Permitting large trees to grow on engineered slopes, increases risks that wind, could topple the tree and displace a large volumes of the earthwork with its roots. Falling trees also pose impact risks to structural features (Olmsted Center, 1998).

In order to prevent further damage to the earthworks and structures below them, all woody vegetation greater than four-inches diameter at breast height should be selectively removed from the engineered slope. After the woody vegetation has been cut, the stumps of deciduous species need to be treated to prevent sprouting and regrowth. Since grubbing out or grinding the woody stumps would cause damage to the historic earthwork and possibly the concrete structure below or

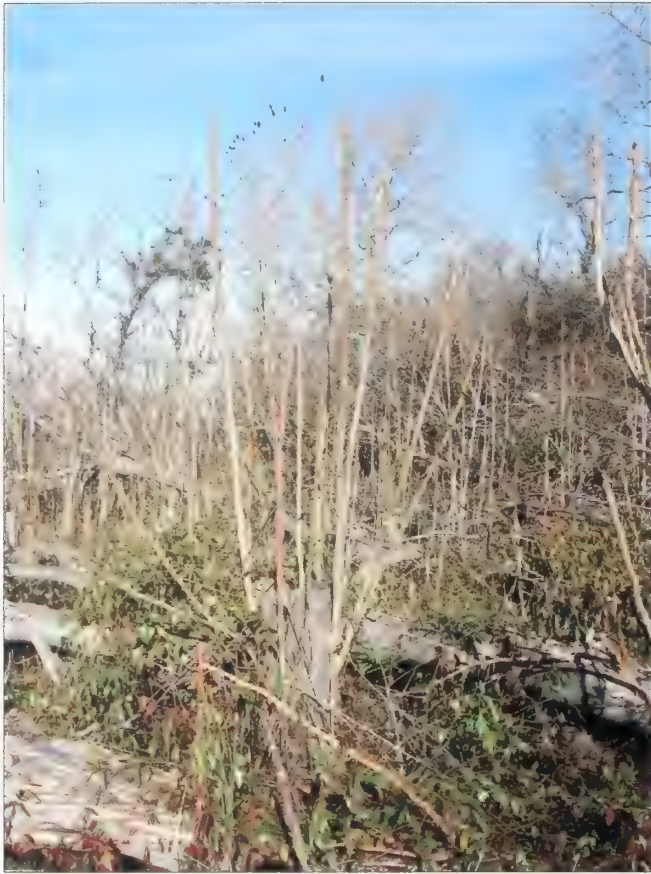
Figure 5.7. Ailanthus stump at Battery Mills. If stumps are not treated after cutting, species like ailanthus (*Ailanthus altissima*) will produce root sprouts and develop into a denser, more vigorous stand of vegetation. Stumps should be cut as flush to ground level as possible and treated with a triclopyr herbicide following the specific manufacturer's label instructions (Olmsted Center, January 2009).

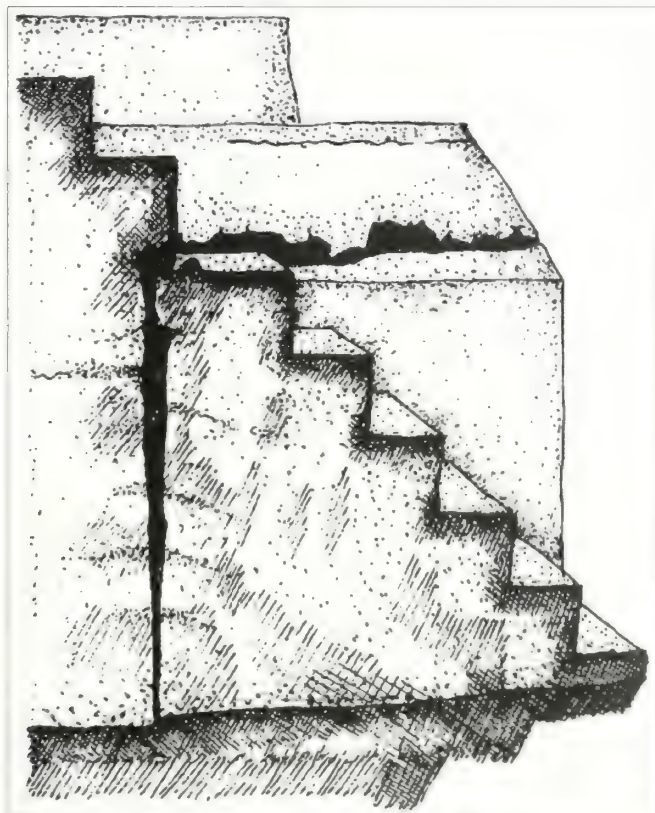
Separation between individually cast concrete elements provides another opportunity for woody vegetation to become established. A void is created between concrete elements due to differential settling creating an opportunity for plant material (Figure 5.10). Even if woody vegetation is not growing on a structure or in a crack or void, the expanding root system of nearby vegetation can find and exploit weaknesses in concrete structures. In addition, as nearby vegetation grows ever larger, there will be an increase in the amount of leaf litter and debris on the concrete structure that will support secondary plants and cause greater moisture retention within the structure surfaces.¹⁰

Figure 5.10. Concrete separation at unreinforced steps. Separation between individually cast concrete elements provides another opportunity for woody vegetation to emerge. The voids can also be exacerbated by growing woody material (Joe C. Freeman et al., *Seacoast Fortifications Preservation Manual, Golden Gate National Recreation Area, San Francisco, California*, United States Department of the Interior, National Park Service and KEA Environmental, July 1999, 148).

As a conservative measure aimed at mitigating structural problems caused or exacerbated by woody vegetation and the concrete structures, all woody vegetation growing on or within four-feet of concrete features should be removed. Both deciduous and evergreen stumps should be treated with a triclopyr herbicide (*Garlon™* brand or approved equal) on the historic concrete structures since removing the live roots and stumps would cause further

structural damage. After the root systems are dead and decayed, the stumps should be carefully removed to the greatest extent practicable, and following this, appropriate concrete repairs should be completed.¹¹

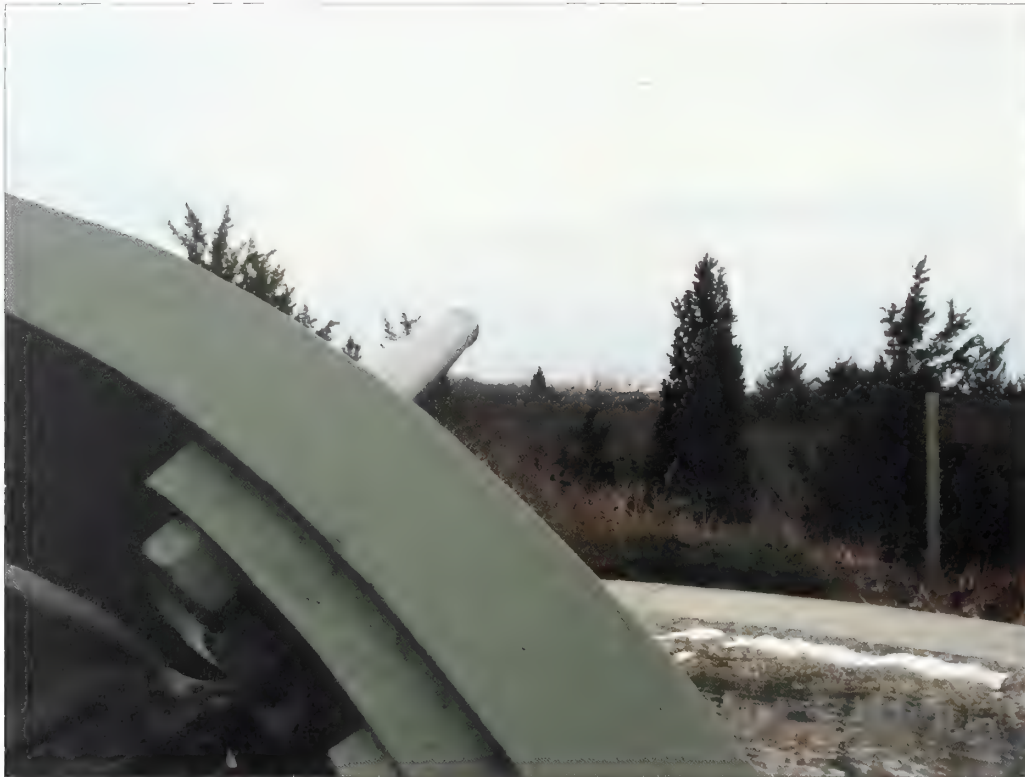
Figure 5.11. View east from south gun platform, Battery Gunnison. The downrange views from gun emplacements and battery commander's stations are significant to the historic operation of the batteries and should be reestablished to greatest extent practicable. The evergreens located closest to the gun in this image are growing upon the engineered slope. Once these have been removed, downrange water views can be evaluated and in limited instances tall, individual woody vegetation removed on a case-by-case basis (Olmsted Center, January 2009).

Managing downrange view comprises a third and final step in managing the woody vegetation growing on or near historic coastal defenses. After removing woody vegetation growing on the engineered slopes and from voids in the battery structure itself, the resulting views to the water must be evaluated. Additional cutting may not be needed once woody vegetation has been managed on the structures and slopes. However, in some instances tall, individual woody vegetation that blocks the view shed can be identified and removed (Figure 5.11). Following removal, as is recommended in the prior two vegetation management recommendations, deciduous stumps should be treated with a triclopyr herbicide to discourage root sprouts and suckering. Cut material must be removed for proper disposal.

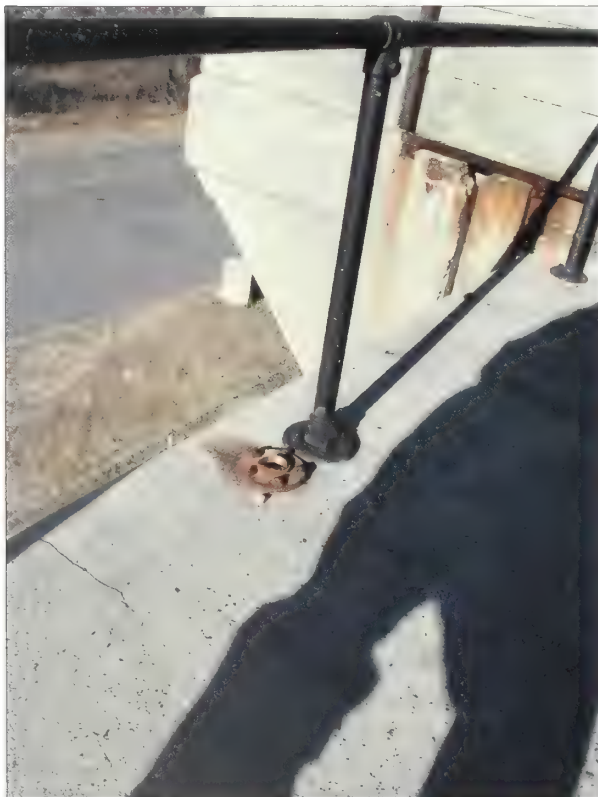
Figure 5.12. View looking west at safety railings, Battery Granger. The existing railing system at Battery Granger displays successive generations of railing components and repairs (Olmsted Center, January 2009).

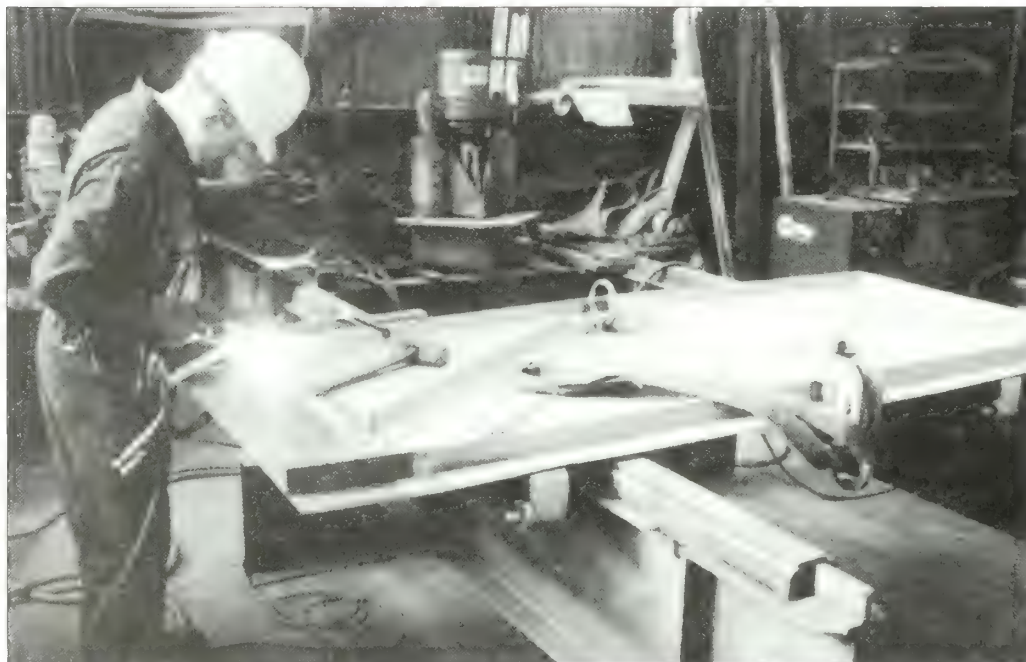
Figure 5.16. Off-site repair of historic metal door for Battery Worth, Fort Casey, Washington. Standing water resulted in the bottom portion of this door being severely deteriorated. The door was removed and is shown being repaired with a new steel plate and angles (From, David M. Hansen, Kimberly Keagle, and Deborah Rehn, *Historic Fortification Preservation Handbook*, Olympia, WA: Washington State Parks and Recreation Commission, 2003, 3.102).

Metal and wood doors and metal gates, windows, and grating are located on gun and missile batteries throughout Sandy Hook. All of these building features require a detailed evaluation that is beyond the scope of this cultural landscape report. However in general terms, sound material with minor corrosion or decay should be treated in place. Loose paint and rust should be removed immediately followed by priming and painting to match the historic finish. A moderate level of repair may also be conducted in place. For example, an operational gate with a missing a hinge spindle should be repaired in place with a new hinge spindle that matches the historic dimensions and finish. If a component is damaged or severely deteriorated, it should be removed and repaired at an off-site shop or newly fabricated to match the existing (Figure 5.16).¹⁶

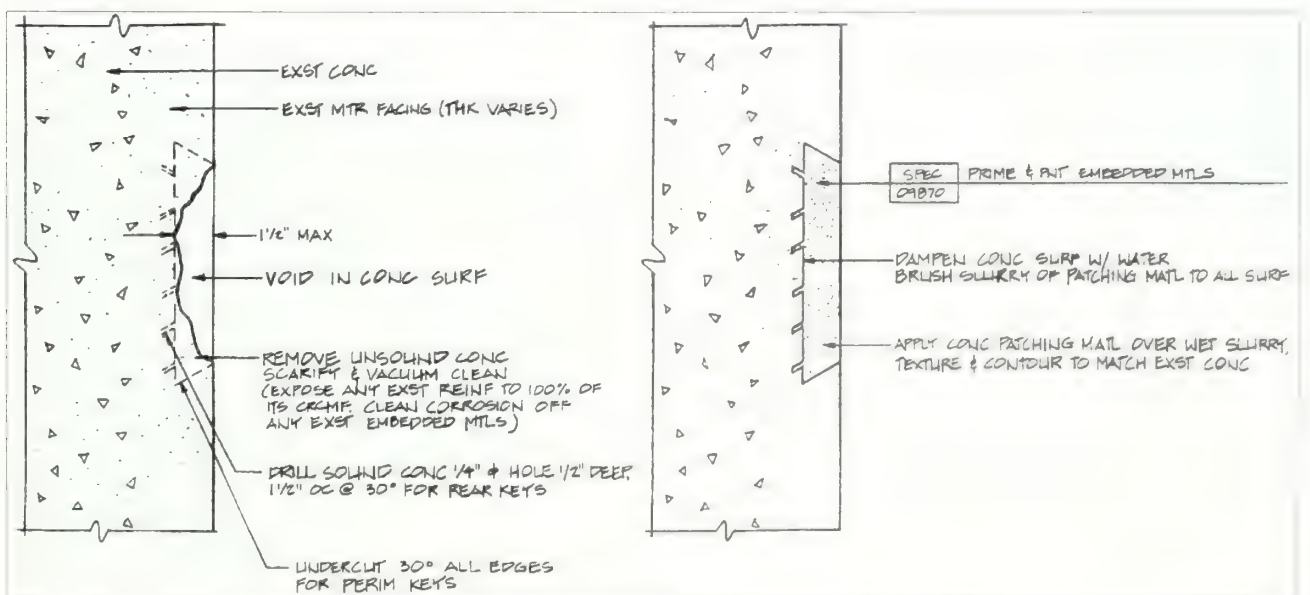
Figure 5.18. Typical repair of spalling concrete surface. The image on the left illustrates the removal of unsound concrete and preparation of the area to receive patching material. On the right, the patch is in place and has been finished to be compatible with the character of the historic concrete. In addition, the prepared area may be lightly coated with an approved bonding agent to promote greater adhesion of the new concrete (Hansen, Keagle, and Rehn, *Historic Fortification Preservation Handbook*, 3.78-3.79).

The removed area should be mechanically cleaned and patching material applied according to the manufacturer's directions. Deep patches will require dowels, welded wire fabric, and other reinforcing. These should be installed using specific items certified for horizontal, vertical, and overhead applications. Finally, the texture and contour of the finished patch should be compatible with the character of the historic concrete (Figure 5.18).¹⁸

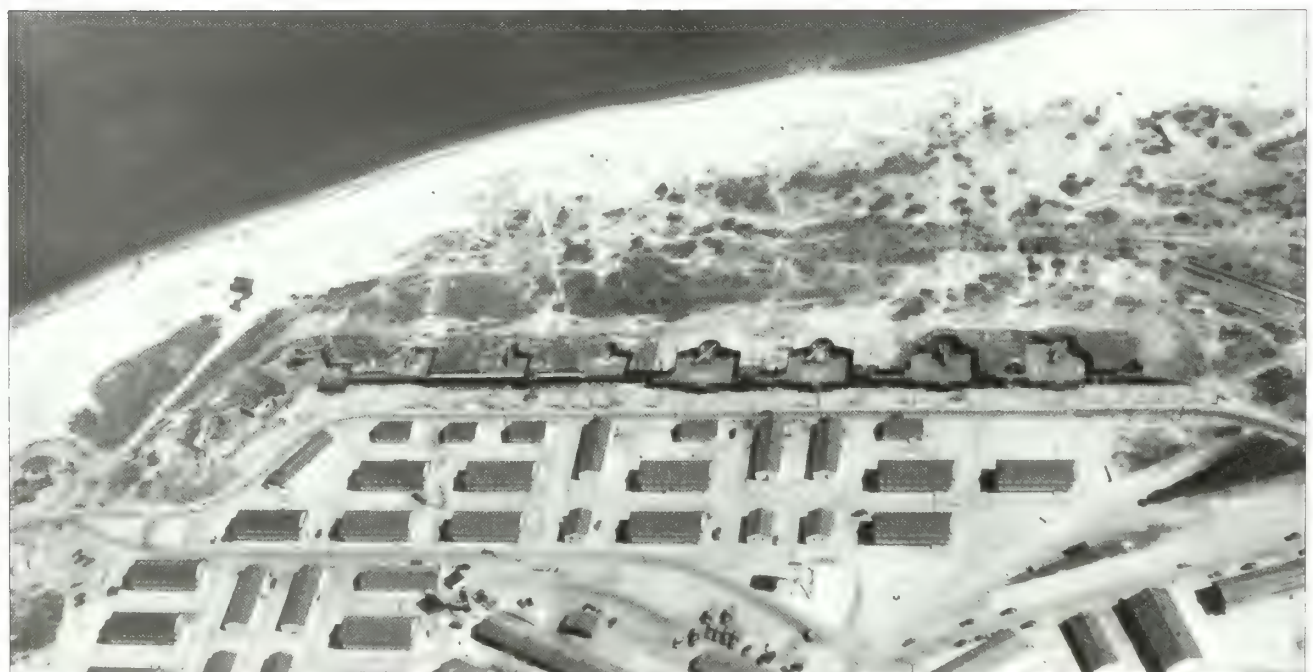
Figure 5.20. Oblique aerial view of Nine Gun Battery, 1942. This World War II-era photograph of Nine Gun Battery, and a portion of Battery Peck (left), indicate they were both finished with an asphalt emulsion paint (also refer to cover photograph). This surface treatment has worn away from gun platforms #3 and #4 (center) and the brighter appearance of the concrete underneath is visible (National Archives, Record Group 661 S, Philip S. Gage Collection, Fort Hancock Folder).

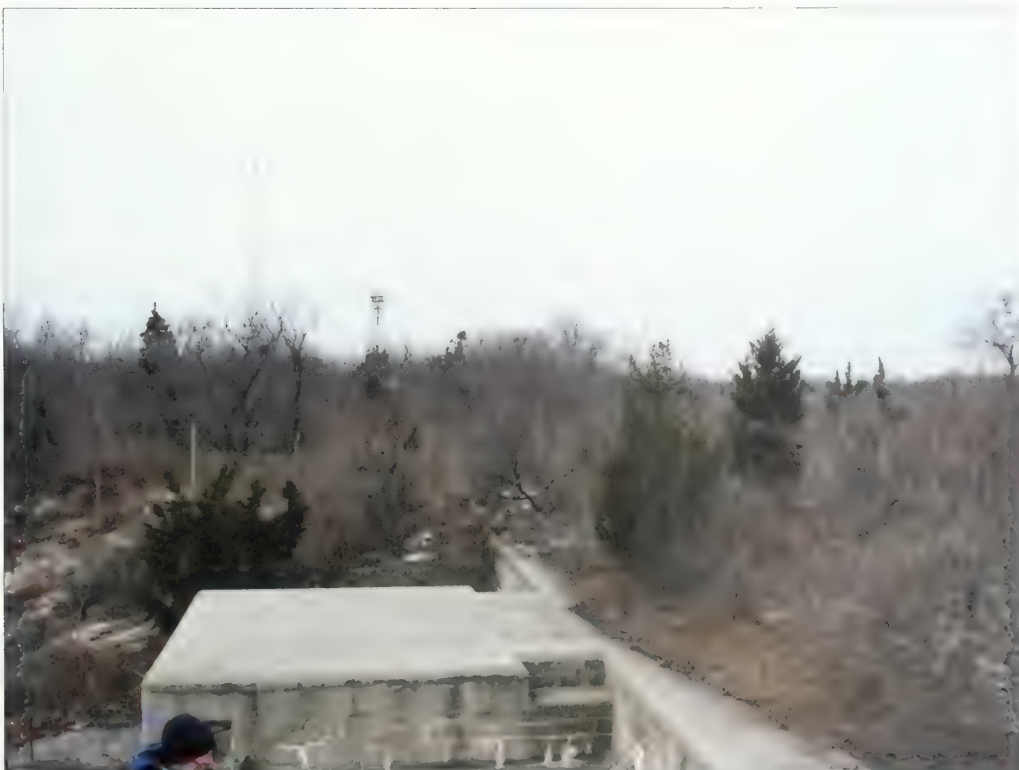
Figure 5.22. View looking west at gun platforms #5 and #6, Battery Urmston. The engineered slope meeting the concrete structure on the west and north sides contains woody vegetation growing on, or within, four feet of concrete structures and should be removed (Olmsted Center, January 2009).

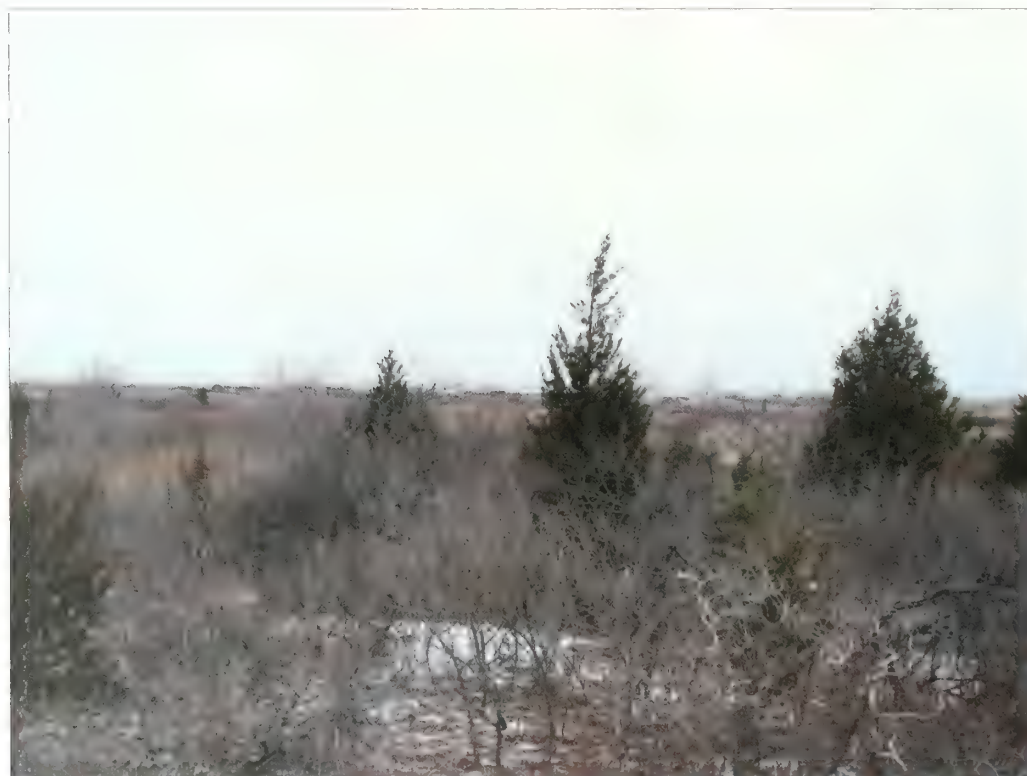
Figure 5.24. View looking east toward water from Battery Urmston. Once woody vegetation larger than 4-inches diameter growing on engineered slopes, and vegetation growing on or within four-feet of concrete features is removed, downrange views should be evaluated to identify additional vegetation to be removed to in order to perpetuate historic views. Lower growing woody vegetation should be retained (Olmsted Center, January 2009).

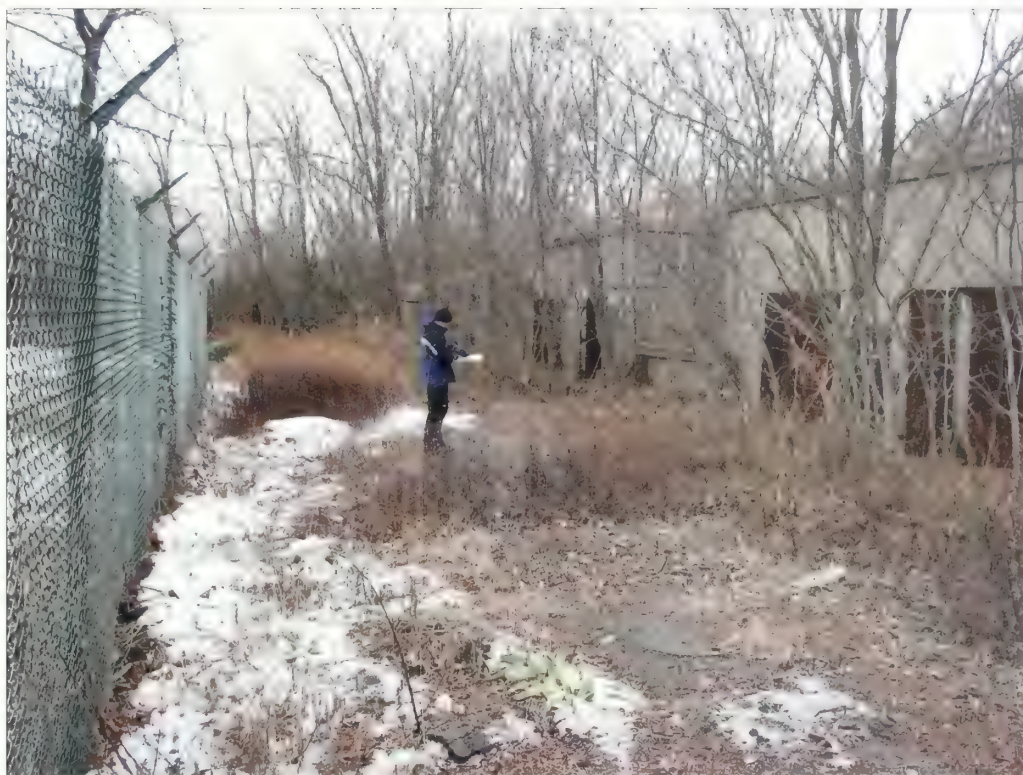
Figure 5.25. U. S. Coast Guard perimeter fence south of Battery Urmston and Morris. After the large woody vegetation has been removed along the perimeter fence, a six-foot wide swath from the fence can be easily maintained with a small tractor and brush hog mowing deck. The mowed swath will provide a convenient route for visitor access to these batteries (Olmsted Center, January 2009).

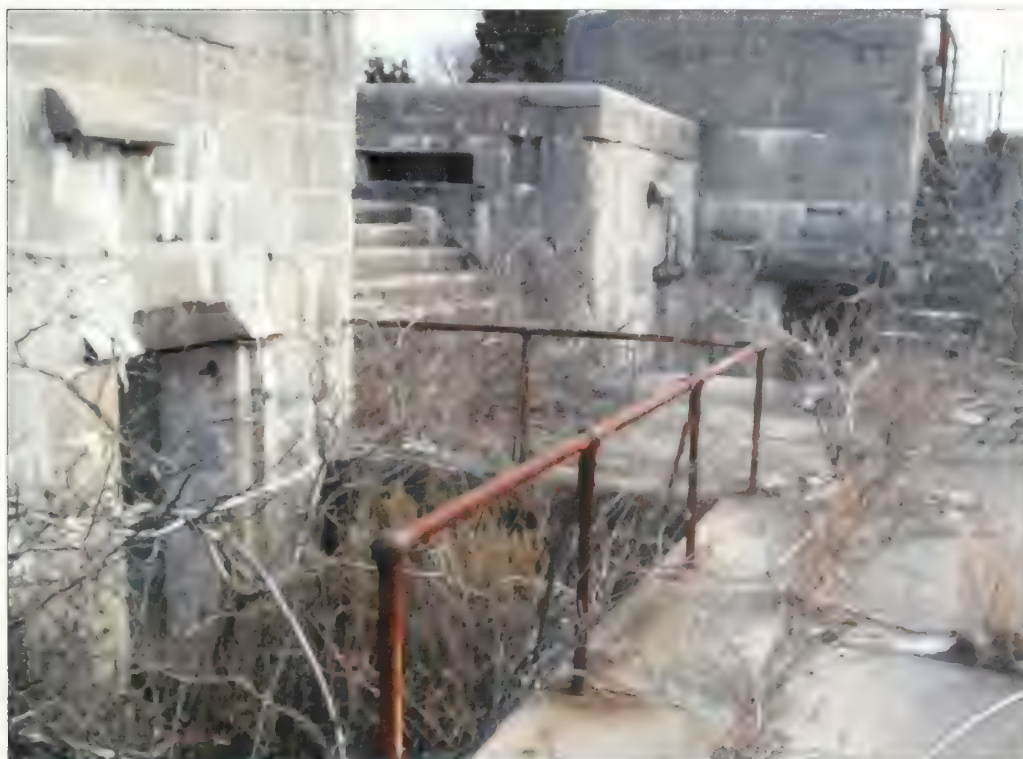
Figure 5.26. Existing historic safety railing at Battery Urmston is fabricated of pipe rail sections and ball joint connectors. After treating corrosion and restoring the historic finish, infill panels should be installed where there is a vertical change equal to or greater than thirty inches in order to provide greater safety at the large openings below the top rails (Olmsted Center, January 2009).

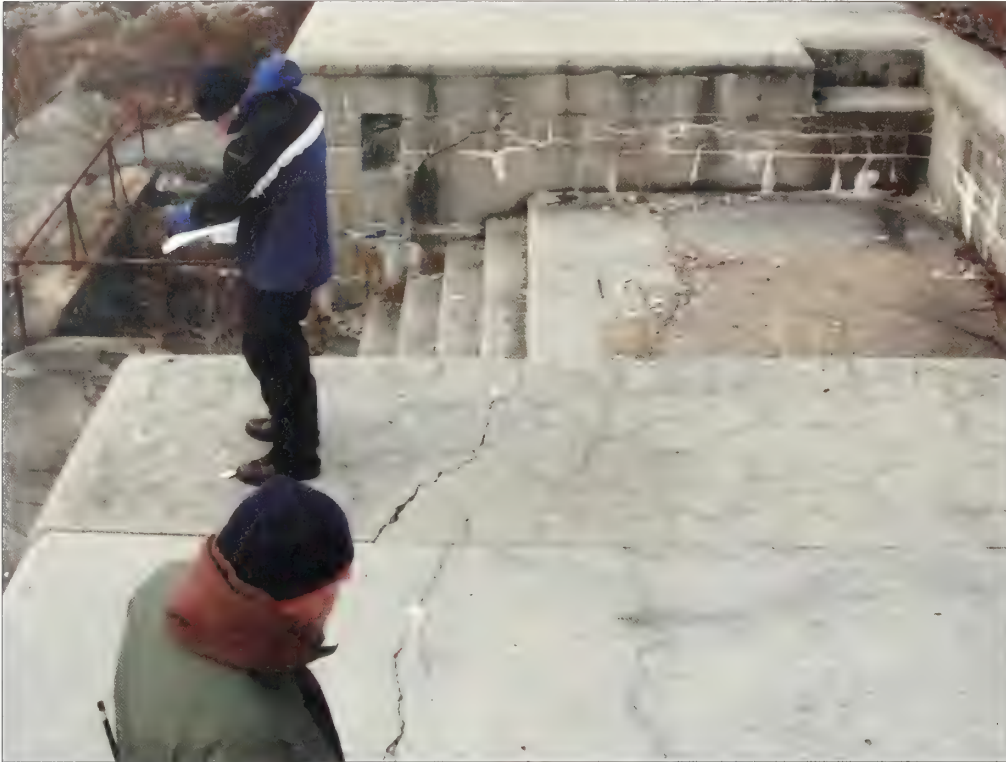
Figure 5.27. View looking down at gun platform #5, Battery Urmston. The tops of the magazines and bomb proofs show less evidence of spalling concrete, yet substantial cracks are present (Olmsted Center, January 2009).

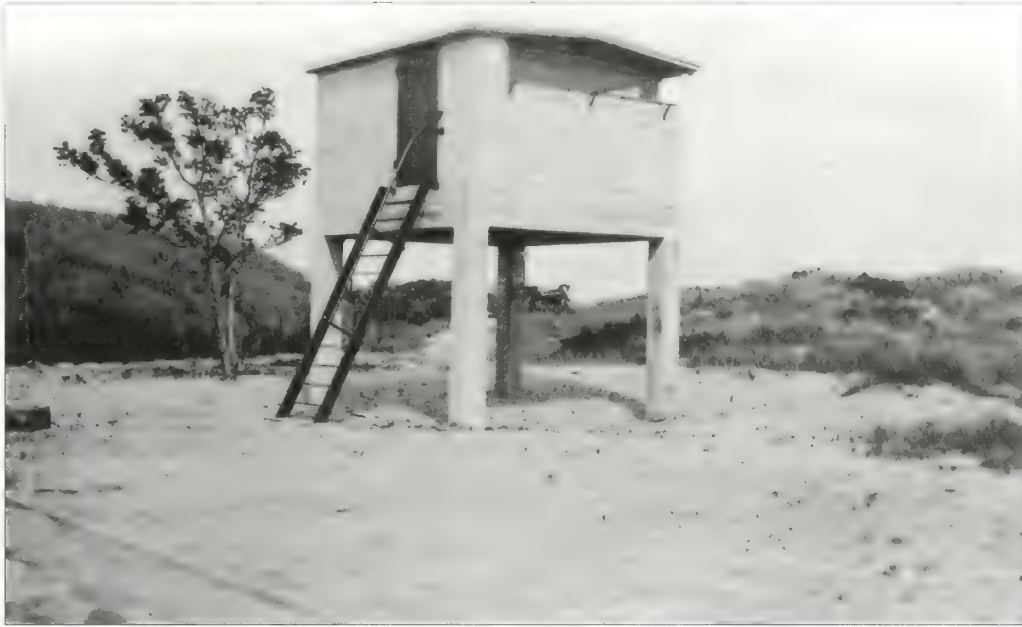
Figure 5.29. Coincidence range finder station, Battery Morris, circa 1920. Note the open character of the adjacent landscape. Woody vegetation should be removed within four feet of the freestanding structure (GATE 7893).

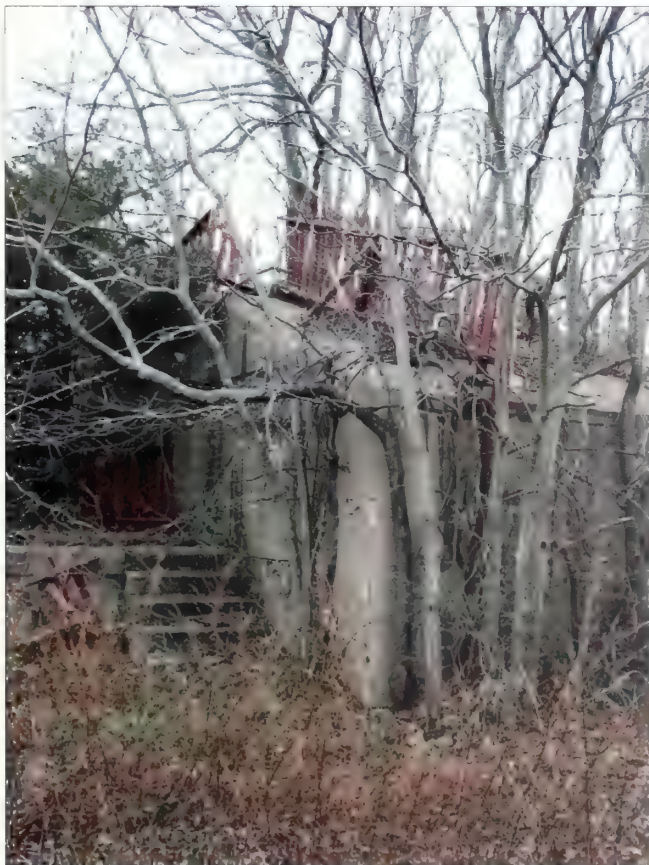
Battery Morris survives in a greatly deteriorated condition (Figure 5.30). Dense growth of vines and trees makes access difficult and blocks downrange views (Figure 5.31). The presence of leaf litter and plant debris perpetuate a damp environment hastening deterioration of concrete and metal surfaces. A wooden non-historic fence, apparently located here for reasons of safety, has deteriorated beyond repair. Concrete surfaces display widespread spalling, and metal fixtures such as handrails and door and window hardware are severely corroded.

Figure 5.30. View looking northeast at Battery Morris. This image shows dense stands of hackberry (*Celtis occidentalis*) growing directly along the south face of the concrete structure (Olmsted Center, January 2009).

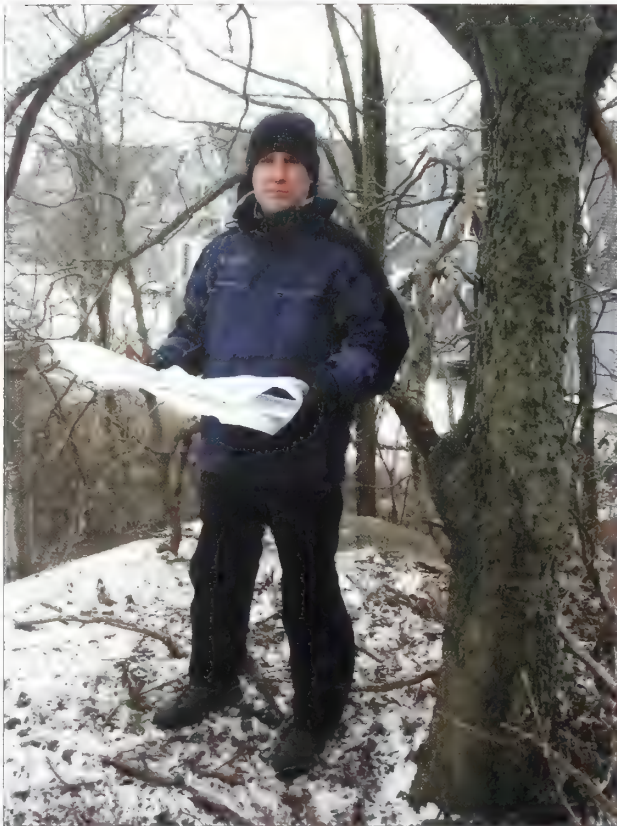
Figure 5.31. Large hackberry growing in the accumulated leaf litter on top of Battery Morris (Olmsted Center, January 2009).

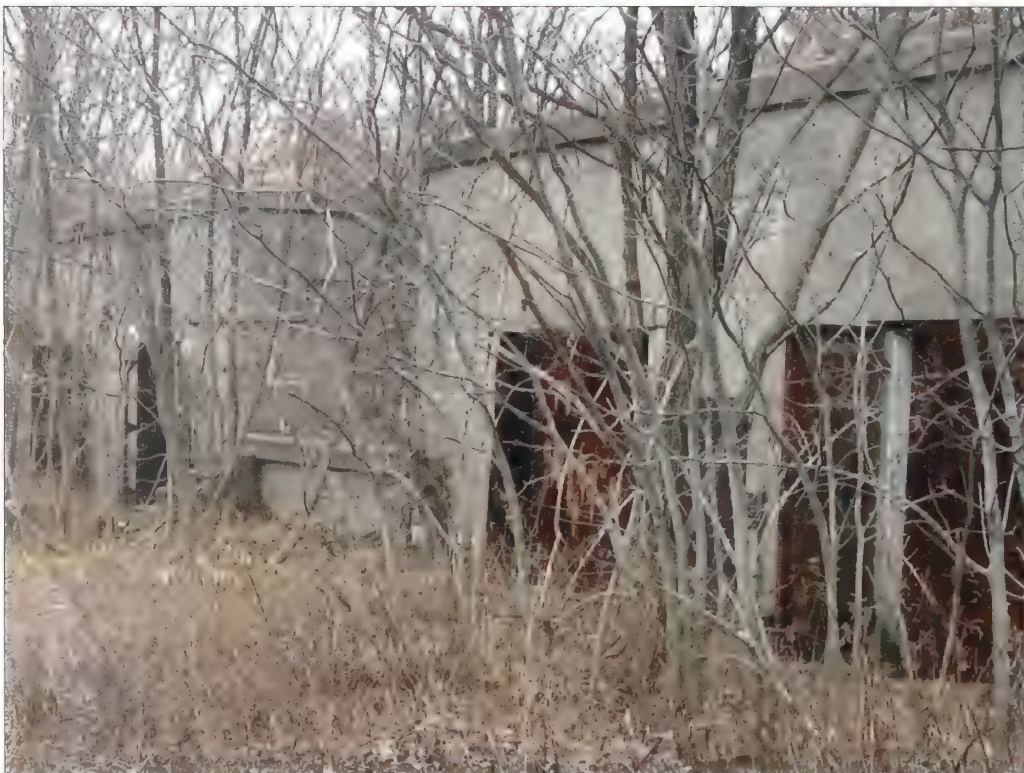
Based on field observations in January 2009, the doors on the south side of Battery Morris appeared to be in good to fair condition (Figure 5.32). Accumulated leaf litter and debris should be removed from the front of the doors in order to remove a source of moisture that will accelerate corrosion.

Figure 5.32. View looking northwest at south facade, Battery Morris. Accumulated leaf litter and debris should be removed from the front of the doors in order to remove a source of moisture that accelerates corrosion (Olmsted Center, January 2009).

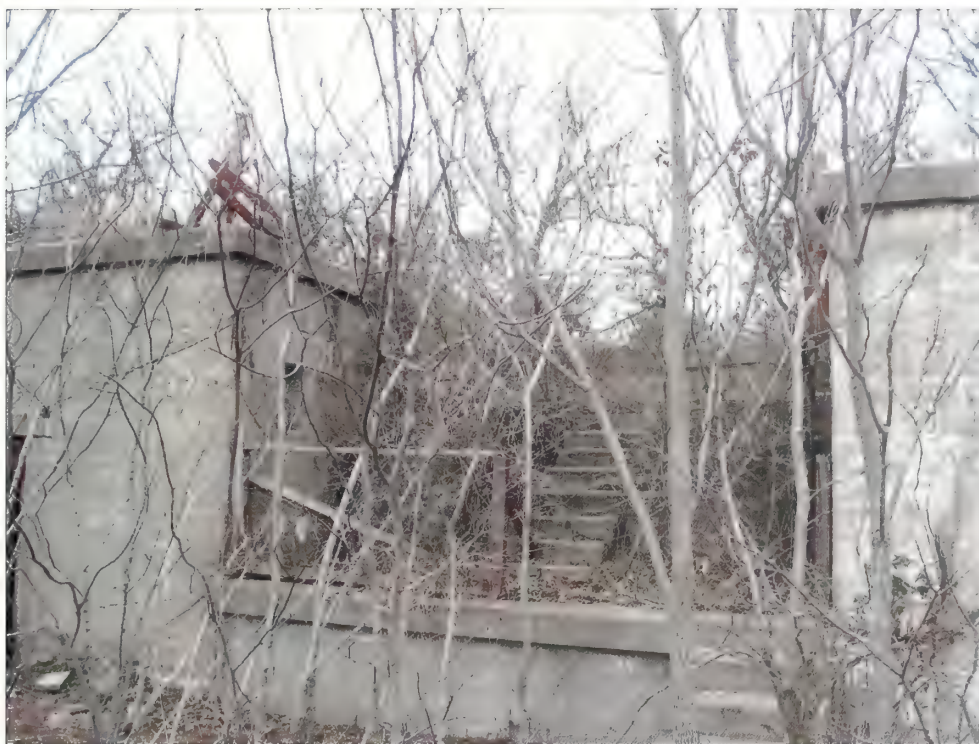
Figure 5.33. Wood guard panels at Battery Morris. The wood panels are not a historic feature and do not comply with safety codes due to the excessive space between the rails and cross brace. The wood guard panels should be removed and great care should be exercised not to damage the historic concrete structures removing fasteners that secured the wood to the concrete (Olmsted Center, January 2009).
